### Exhibit 3: Site Photographs

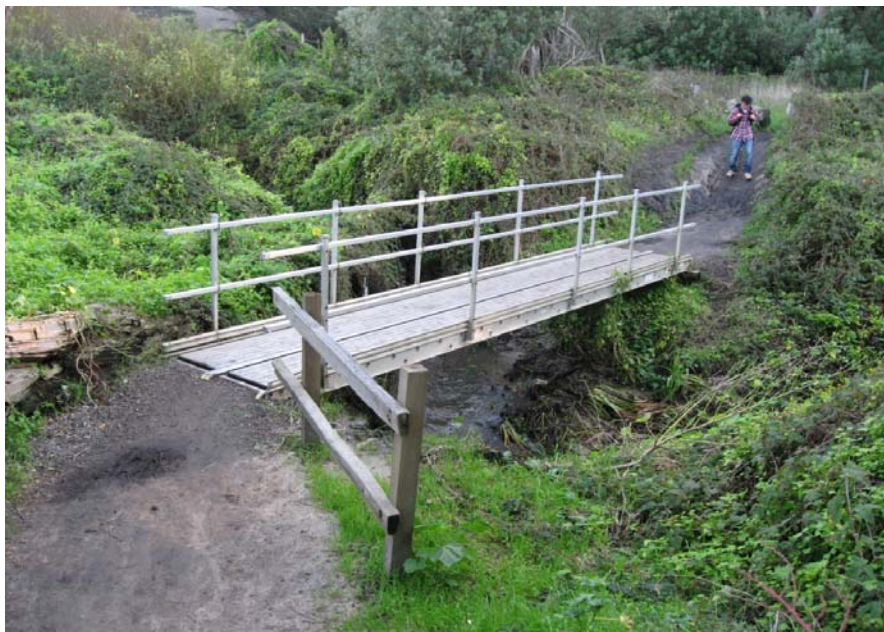
The upper photo shows the beginning of the trail, heading from the street toward the ocean. The banks of San Vicente Creek are eroding so severely that the bridge in this photo was in danger of collapsing, and had to be replaced in April with a second, slightly longer temporary bridge (pictured on the next page). Erosion continues to threaten the new bridge, and a permanent solution is needed.

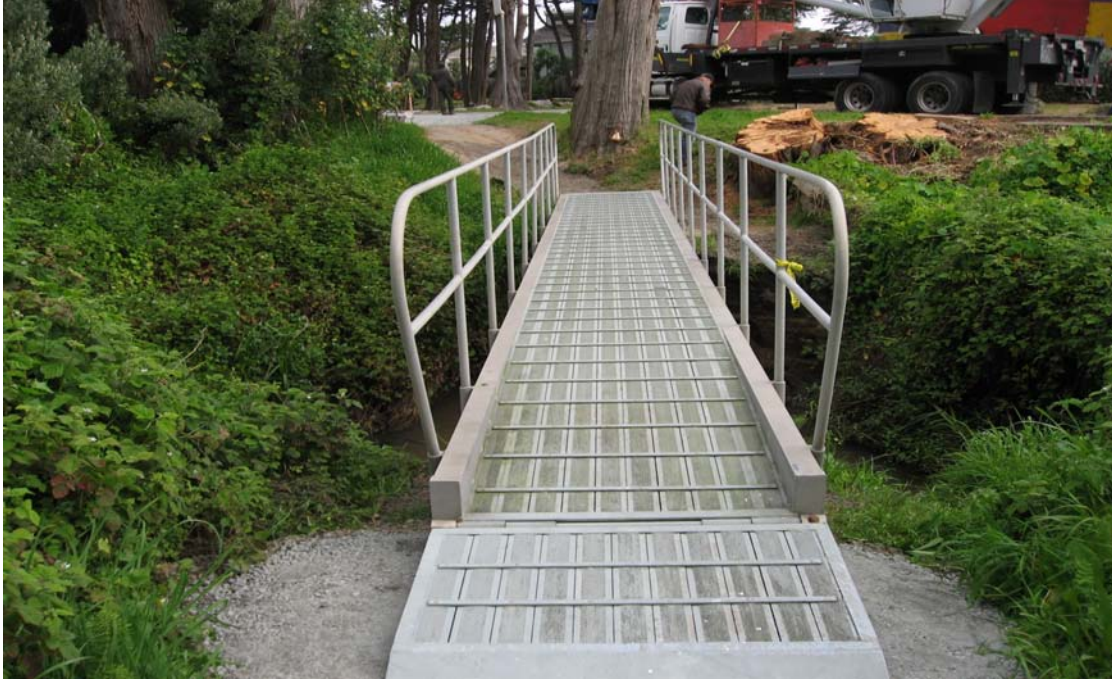
The upper photo shows the new temporary bridge, looking back toward the Fitzgerald Marine Reserve parking lot across the street. This bridge was installed under emergency conditions, and is not designed to be permanent. The lower photo shows the condition of the trail. Improvements are needed to make this trail ADA-compliant.

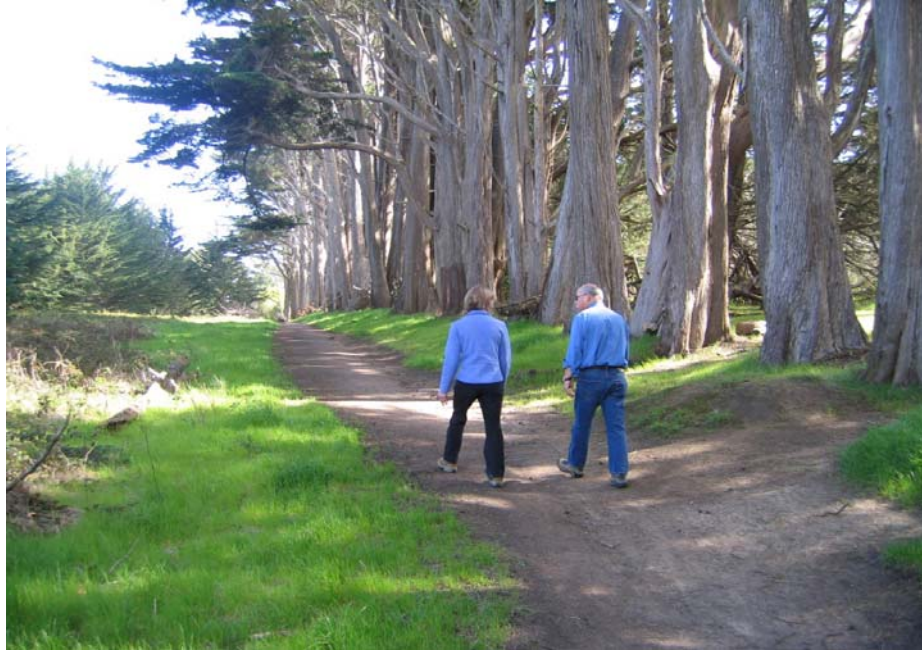
The proposed Coastal Trail will be built along existing dirt trails, portions of which need little improvement.

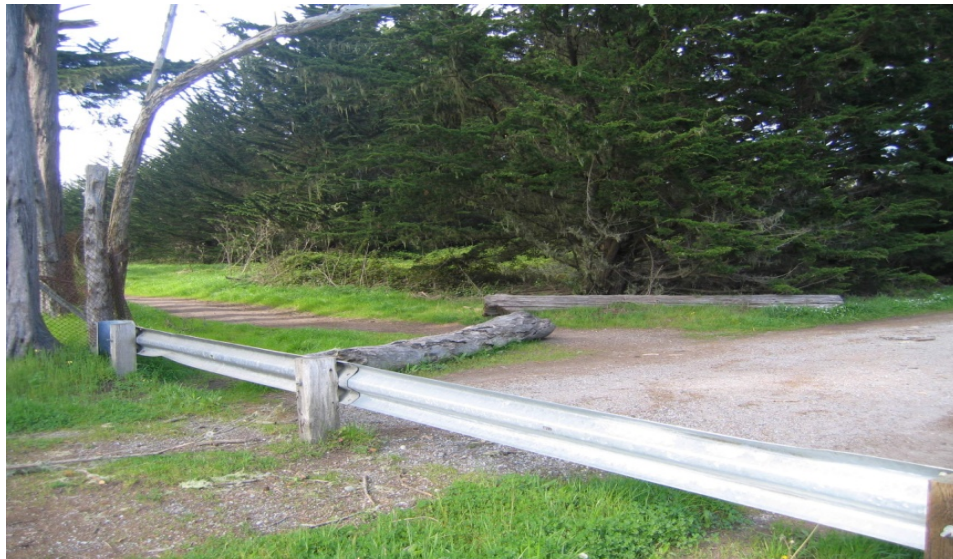
The end of this proposed segment of the Coastal Trail is pictured above, running between the two downed logs and intersecting Cypress Avenue. Hikers can walk around the traffic barrier to access the Bluff Trail, which loops back along the oceanside cliffs to the Fitzgerald Marine Reserve parking lot. Because the cliffs are highly erosive, the Bluff Trail cannot be improved to meet ADA standards. Users with limited mobility can return to the parking lot via the trail on which they came.
